# PHASE IV REPORT

### RESULTS AND INTERPRETATION OF DRILLED-IN PILE TEST PROGRAM

EXISTING LOCKS AND DAM NO. 26  
MISSISSIPPI RIVER, ALTON, ILLINOIS

Woodward-Clyde Consultants  
Chicago, Illinois

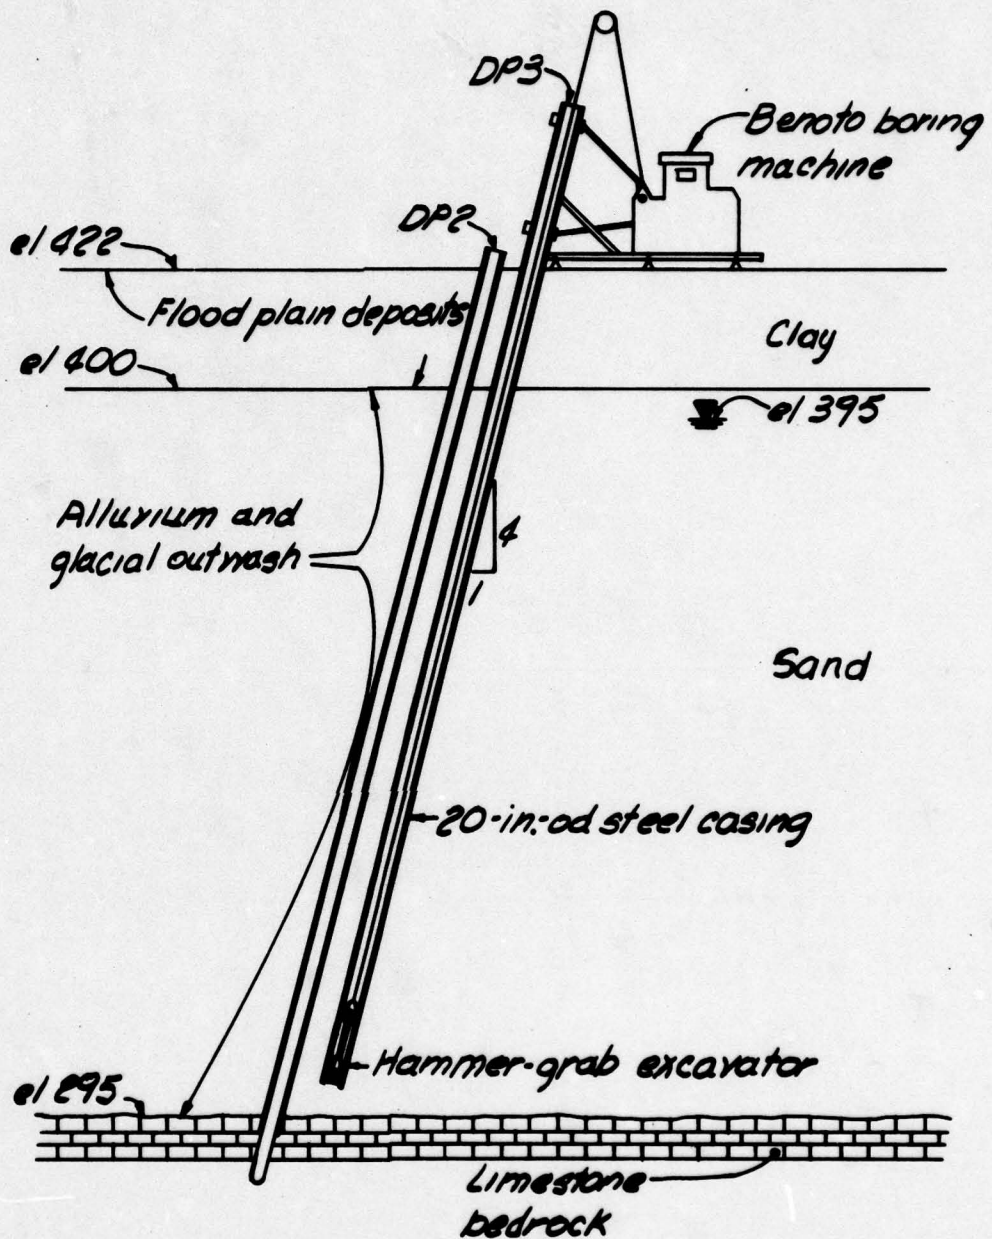
Woodward-Clyde Consultants Y7C825 Phase IX</p>	<p><b>Fig. 2.1</b></p>

<p><b>DRILLED-IN PILE TEST PROGRAM</b></p>	
<p><b>INSTALLATION OF DRILLED-IN PILES WITH BENOTO MACHINE</b></p>	
<p>FOUNDATION INVESTIGATION AND TEST PROGRAM EXISTING LOCKS AND DAM No. 26 ST LOUIS DISTRICT, CORPS OF ENGINEERS. DACW43-78-C-0005</p>	
<p>

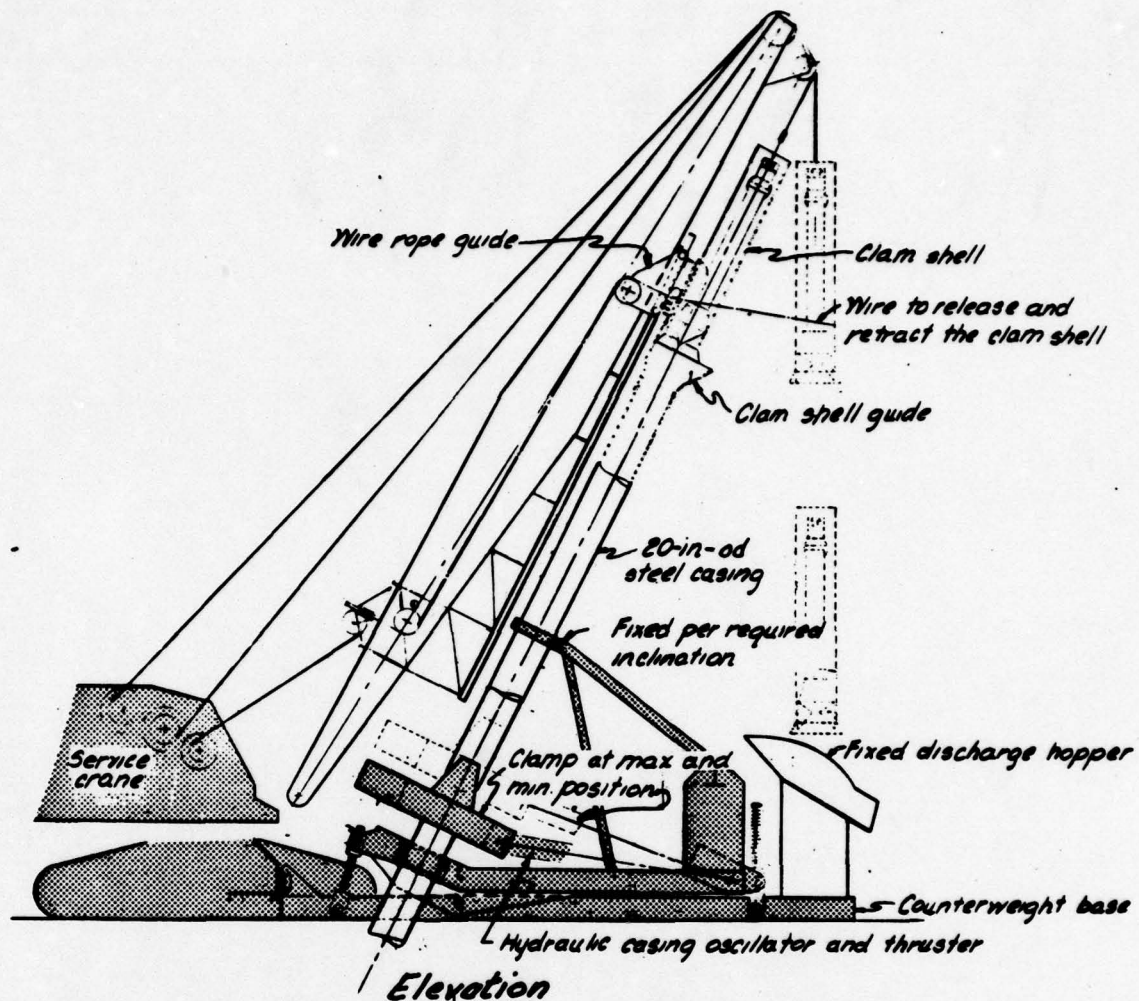
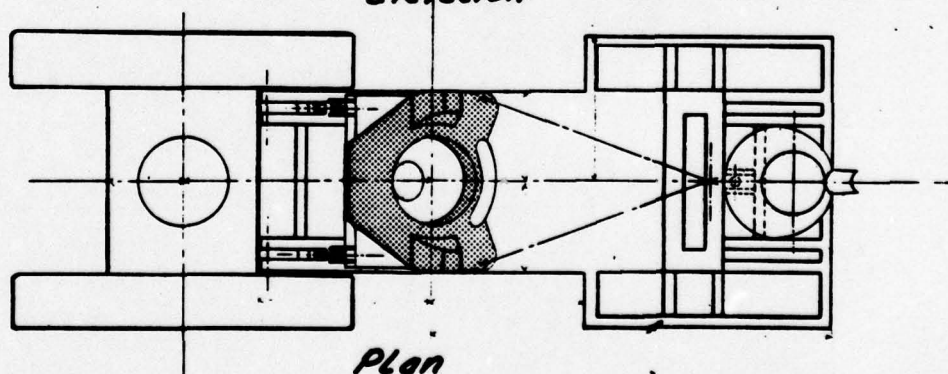
Woodward-Clyde Consultants Y7C025 Phase III	<b>Fig. 2.2</b>

<b>DRILLED-IN PILE TEST PROGRAM</b> <b>CASING OSCILLATOR</b> <b>INITIALLY PROPOSED</b> <b>BY CONTRACTOR</b> <b>(NOT USED)</b>	
FOUNDATION INVESTIGATION AND TEST PROGRAM EXISTING LOCKS AND DAM No. 26 ST LOUIS DISTRICT, CORPS OF ENGINEERS. DASH-75-0-0000

The general testing contractor initially proposed to use a casing oscillator that operates on the same principle as the Benoto machine, but is of a more recent design. The proposed casing oscillator was similar to that used by the general testing contractor on a dam repair project for the Corps of Engineers at Wolf Creek, Tennessee. As illustrated schematically in Fig. 2.2, the equipment consists of two major parts; the hydraulic casing oscillator and thruster, and a service crane with wire rope guide and clamshell. Unfortunately, the configuration of the equipment was such that the service crane, during installation, would be located over the numerous items of instrumentation installed to measure ground movements, thus making them inaccessible for measurements during progress of the work. The Contractor was given the option to design and construct an elevated working platform that would permit access to the instruments under the crane and the casing oscillator. He elected to mobilize a Benoto machine which would not interfere with the instrumentation.

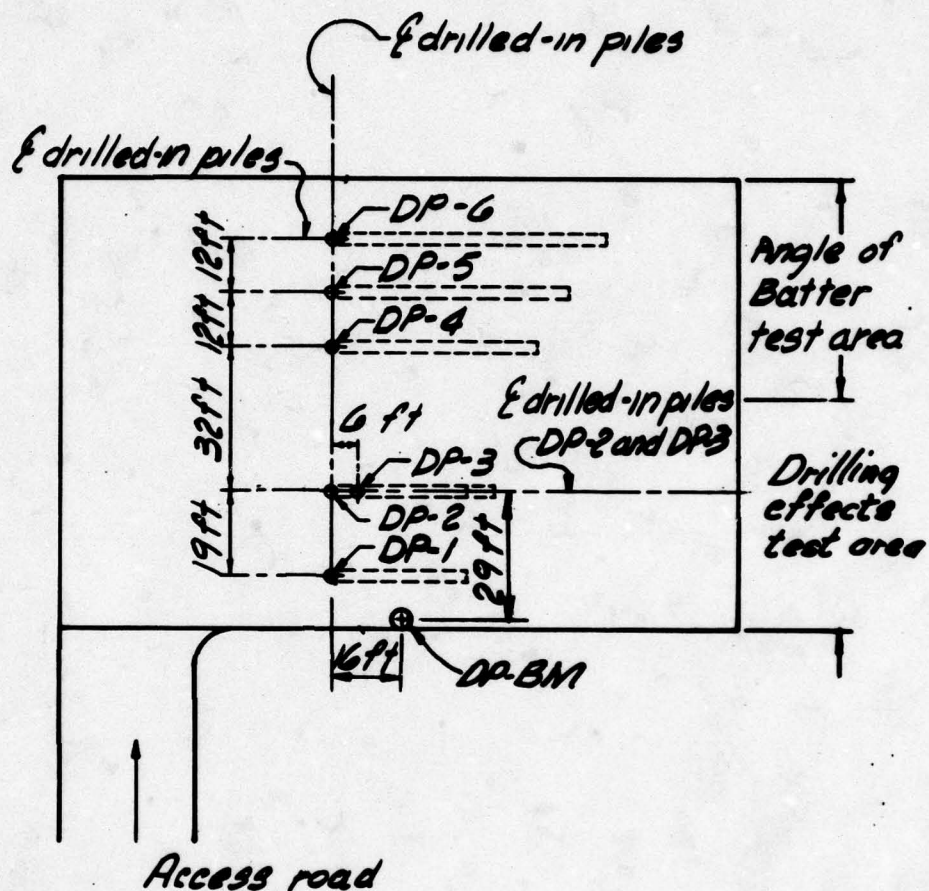
Woodward-Clyde Consultants V7C825 Phase II	<b>Fig. 2.4</b>

<b>DRILLED-IN PILE TEST PROGRAM</b> <b>PLAN OF DRILLED-IN PILE TEST AREA</b>	
FOUNDATION INVESTIGATION AND TEST PROGRAM EXISTING LOCKS AND DAM NO. 28 ST. LOUIS DISTRICT, CORPS OF ENGINEERS. DAW43-78-C-9985

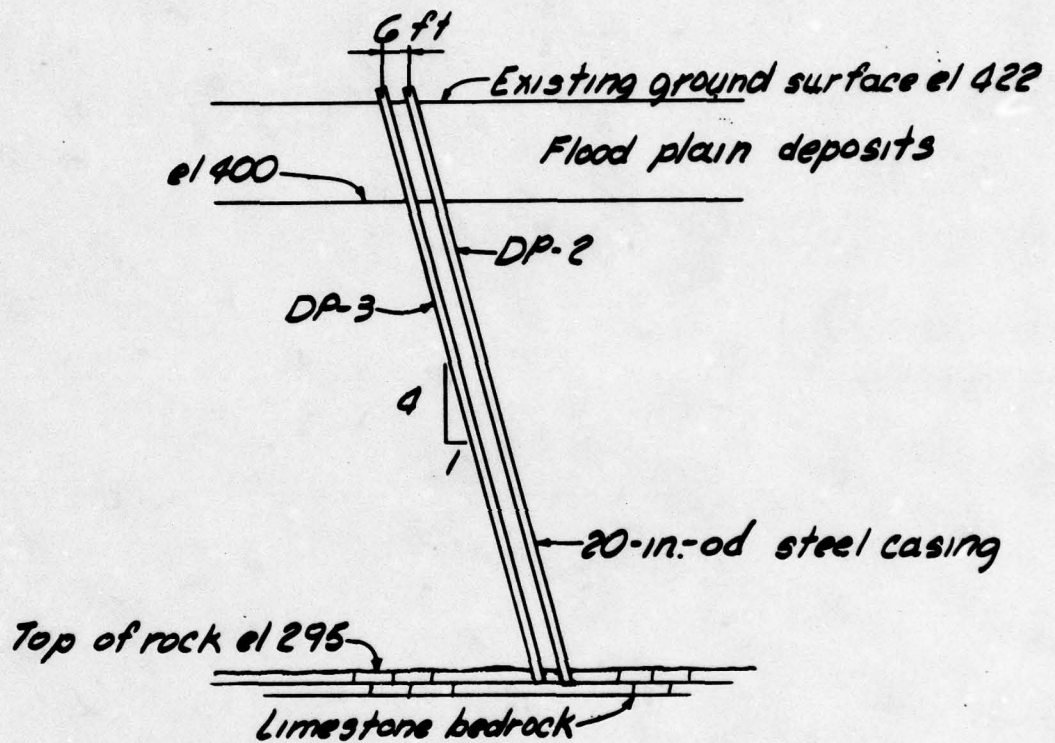
Woodward-Clyde Consultants <small>YTC825 Phase II</small>	<b>Fig. 2.5</b>

Note:  
See Fig 2.4 for location  
of piles

<b>DRILLED-IN PILE TEST PROGRAM</b>  <b>PROFILE OF DRILLED-IN PILES</b> <b>DP2 AND DP3</b>	
<small>FOUNDATION INVESTIGATION AND TEST PROGRAM  EXISTING LOCKS AND DAM No. 28  ST LOUIS DISTRICT, CORPS OF ENGINEERS.  DACW43-78-C-0008</small>

Piles DP2 and DP3 were to be installed on 6 ft center to center also on a 4 to 1 batter as shown in Fig. 2.5. After drilling the shaft and socket, a steel H beam stub core was to be placed and each pile filled with tremie concrete. Construction operations were to be observed and documented to gain information on production time, control of water level in the casing, and removal of cobbles and boulders.

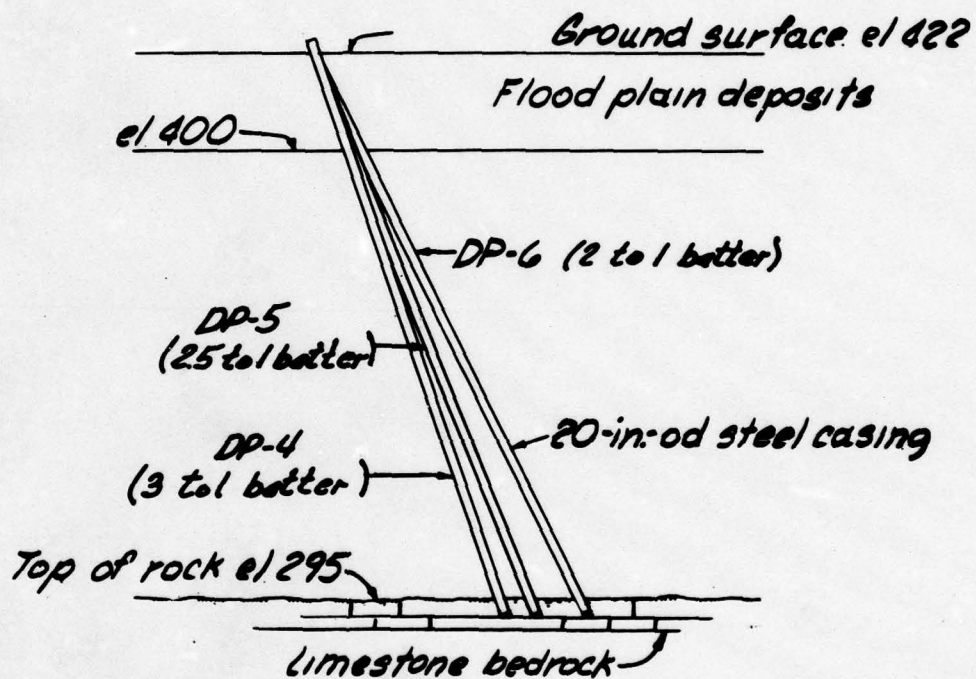
Woodward-Clyde Consultants VTC026 Phase II</p>	<p><b>Fig. 2.6</b></p>

Note:  
See fig 2.4 for location  
of piles

<p><b>DRILLED-IN PILE TEST PROGRAM</b></p> <p><b>PROFILE OF PROPOSED DRILLED-IN PILES DP4, DP5 AND DP6</b></p>	
<p>FOUNDATION INVESTIGATION AND TEST PROGRAM EXISTING LOCKS AND DAM No. 26 ST LOUIS DISTRICT, CORPS OF ENGINEERS. DACW43-78-C-0000</p>	
<p>

It was planned as part of this test program to attempt to excavate (but not concrete) three drilled-in piles at batters of 3 to 1, 2.5 to 1, and 2 to 1, as shown in Fig. 2.6. The piles would consist of advancing 20-in.-od steel casings through the alluvial and glacial deposits and at least 1 ft into rock and drilling of a 4-ft socket in rock. The installation operations were to be observed and documented to gain information on excavation efficiency at flat angles of batter and to assess the flattest practical angle of batter. No measurement of soil movements was planned for these tests. These tests were not made because sufficient information was obtained from the first three piles at a 4 to 1 batter to conclude that flatter angles of batter would not be feasible.

- (5) it was originally planned to install piles at locations DP4, DP5, and DP6 at batters of 3 to 1, 2.5 to 1, and 2 to 1. As noted in Section 2.4.4, due to the slow progress of excavating the 4 to 1 piles, it was deemed potentially unproductive to install piles at the flatter batters. That work was not done.

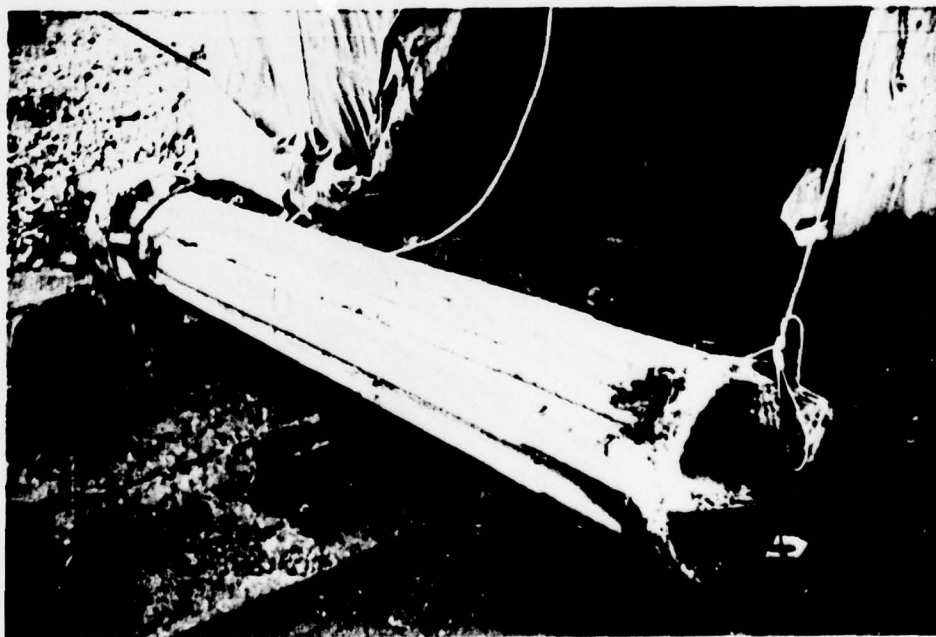
Fig. 2.8

*Hammergrabs*

*Rock chisel*

*Note:  
Specifications for hammer-  
grabs are in section 2.3.2*

Additional variations or modifications included using a smaller diameter hammergrab (Grab A), adding weight to Grab B by welding on steel plates, cutting away portions of the body of Grab B to reduce its cross-sectional area, using three-pronged jaws and two-pronged jaws on the same hammergrabs, and loosening the soil with the rock chisel.

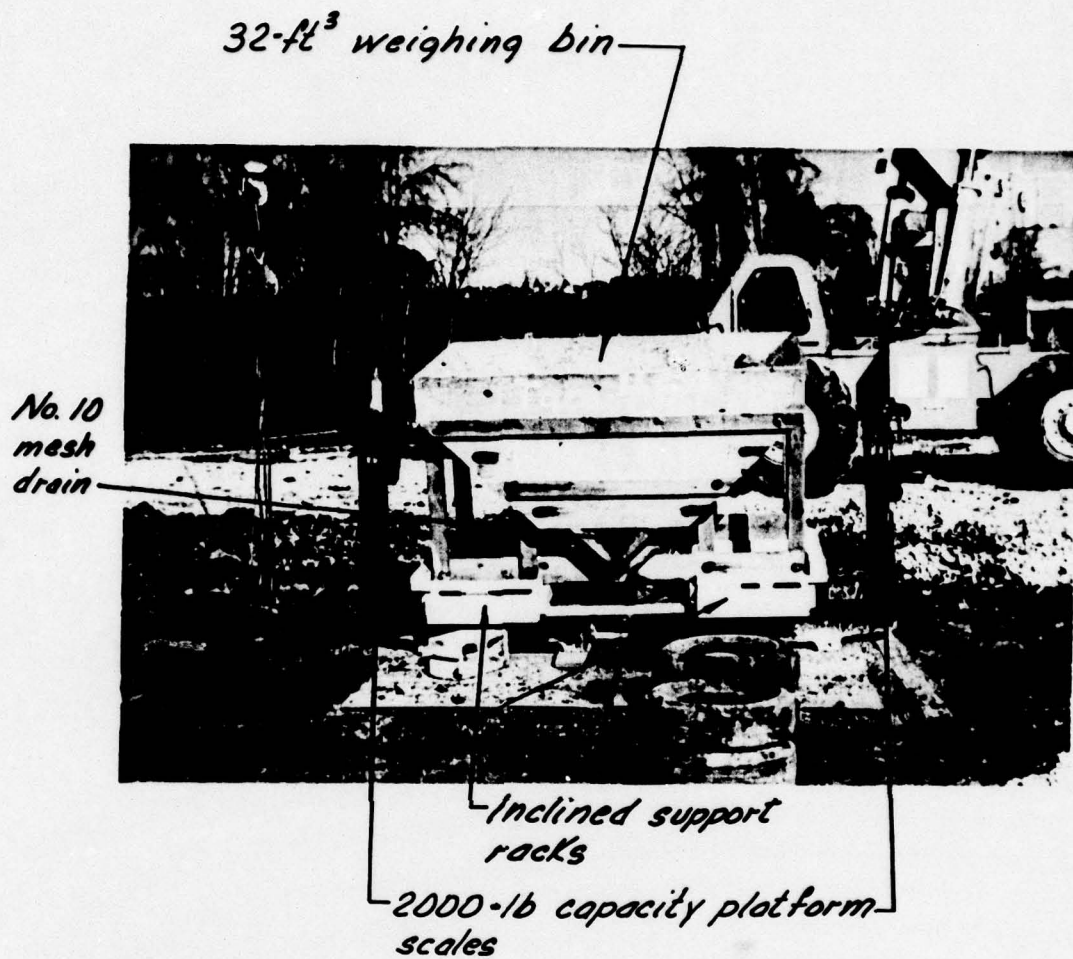
<b>DRILLED-IN PILE TEST PROGRAM</b>	
<b>WEIGHING BIN AND SCALES</b>	
FOUNDATION INVESTIGATION AND TEST PROGRAM EXISTING LOCKS AND DAM No. 26 ST. LOUIS DISTRICT, CORPS OF ENGINEERS. DACW43-78-C-0005

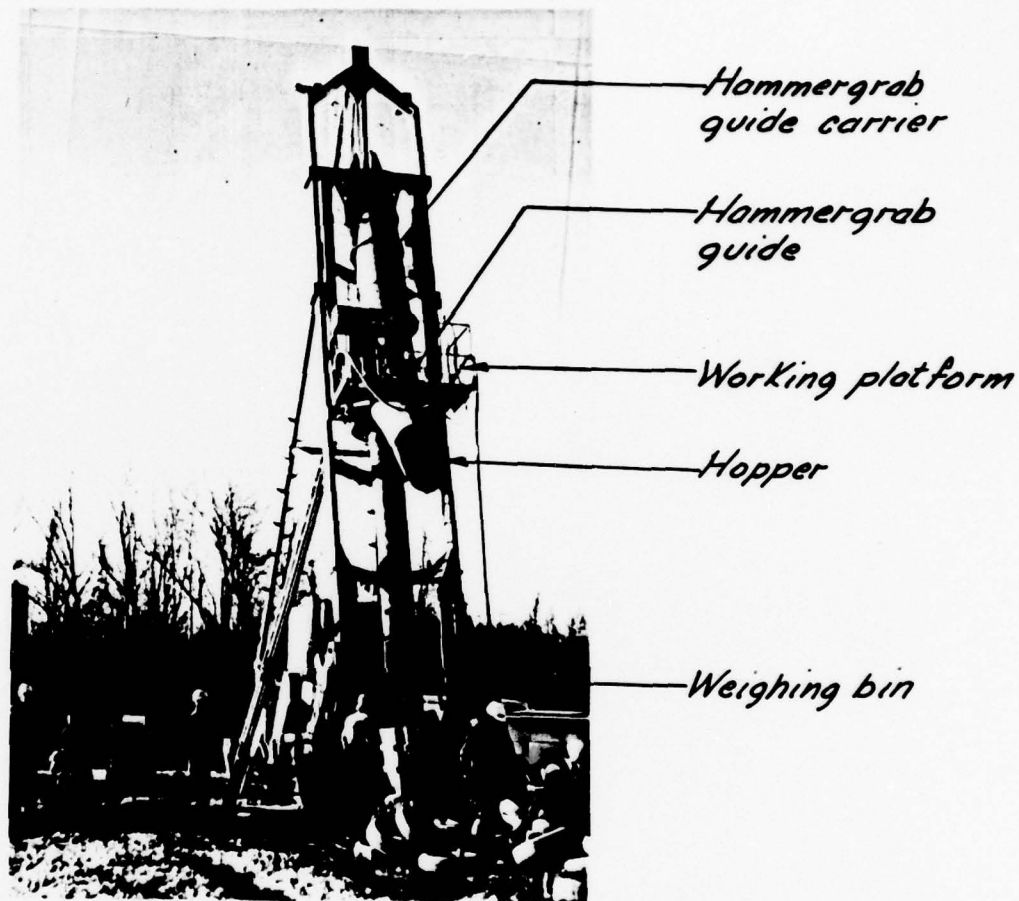
# BENOTO MACHINE SET UP FOR DRILLING

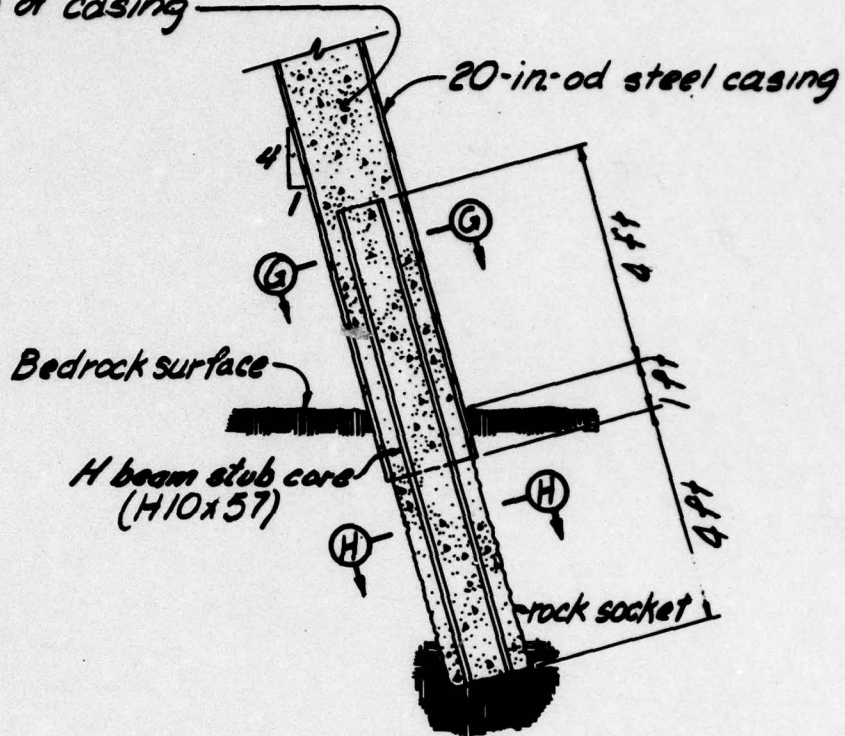
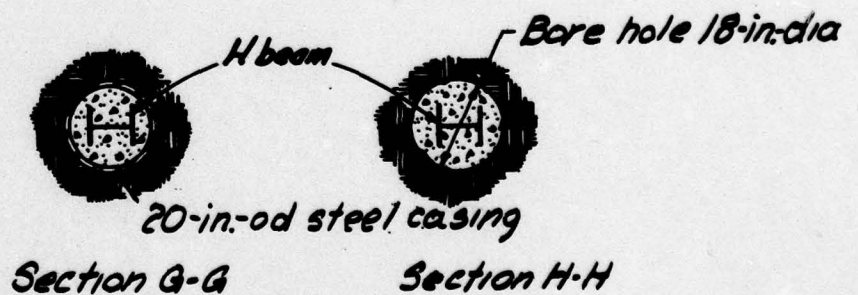
Filled with concrete  
to top of casing

<b>DRILLED-IN PILE TEST PROGRAM</b>  <b>ROCK SOCKET DETAIL</b>	
<small>FOUNDATION INVESTIGATION AND TEST PROGRAM  EXISTING LOCKS AND DAM No. 26  ST LOUIS DISTRICT, CORPS OF ENGINEERS.  DACW43-78-C-0008</small>

After cleaning the hole, the H beam stub core was inserted into the rock socket and concrete placed by tremie method. Details of the stub core and rock socket are shown in Fig. 2.12.

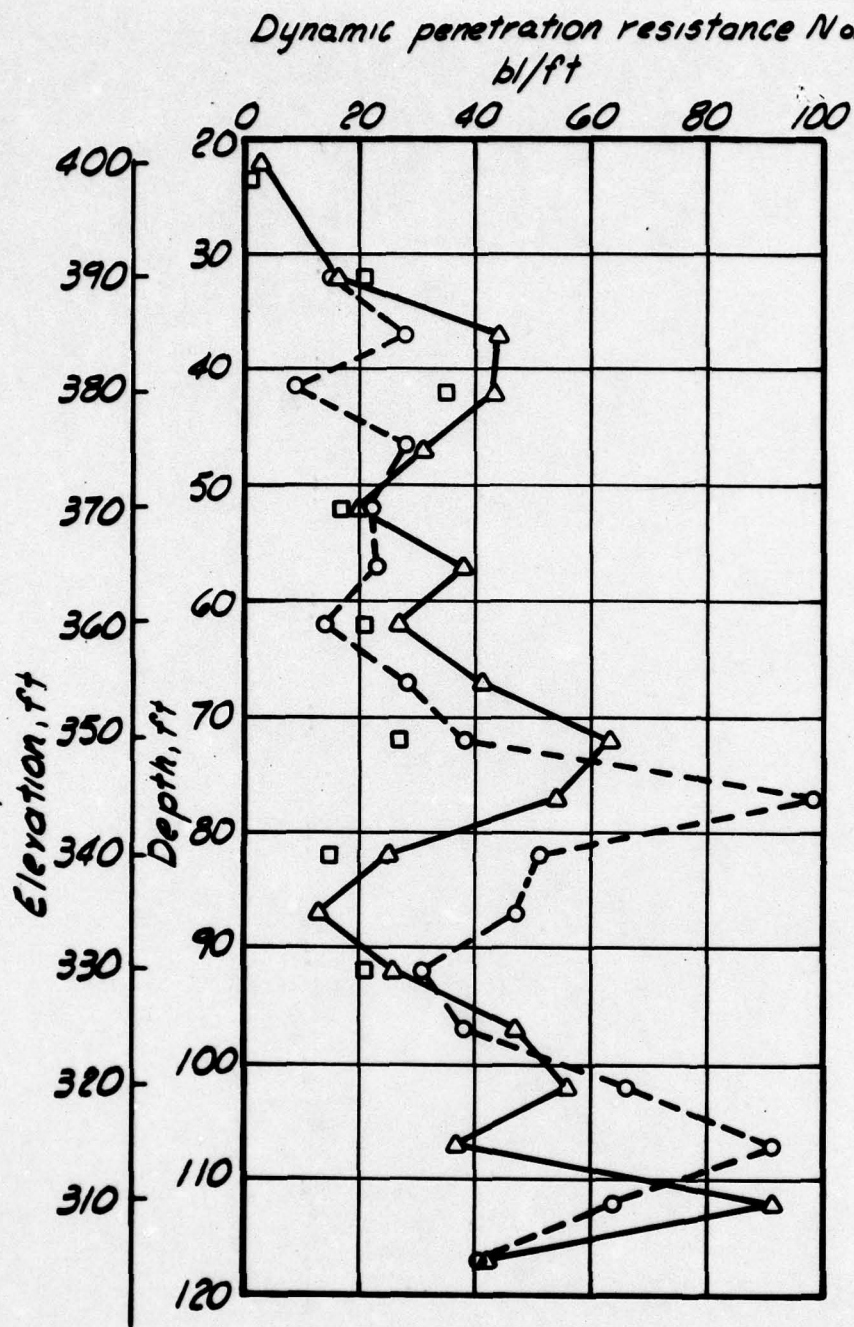
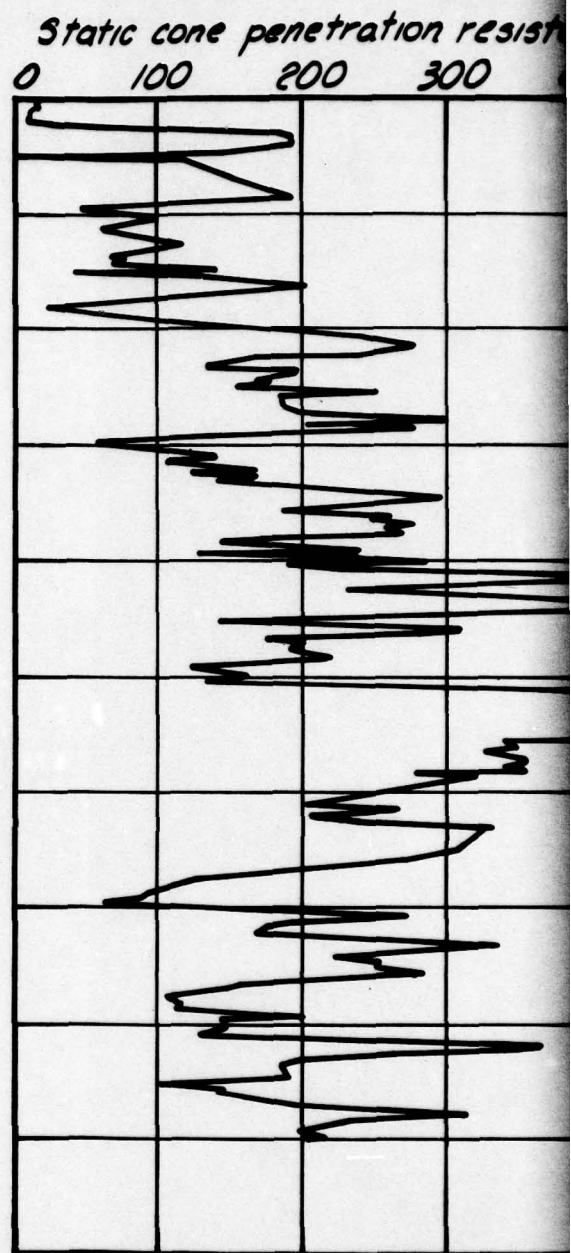
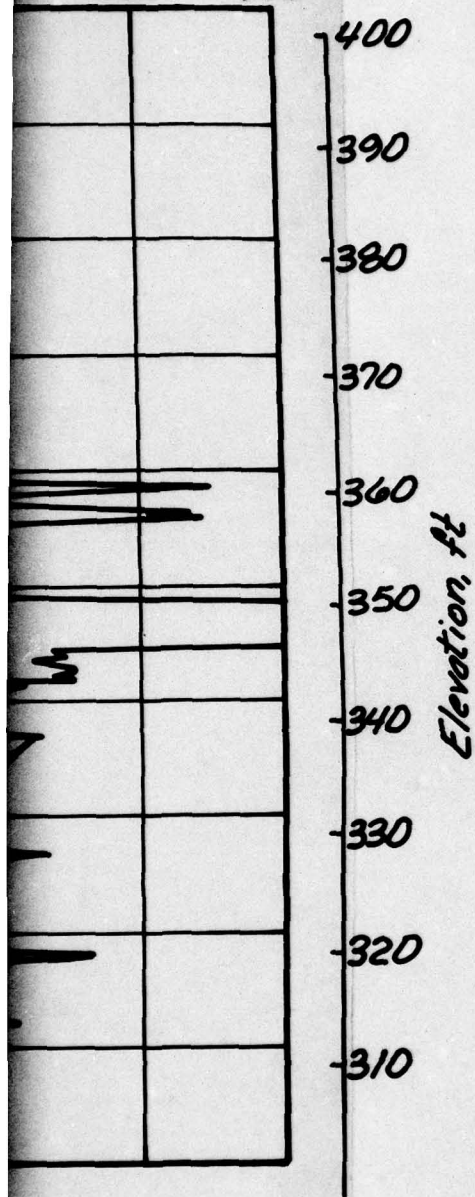
<b>Woodward-Clyde Consultants</b> <small>V7C826 Phase III</small>	<b>Fig.3.2</b>

<b>DRILLED-IN PILE TEST PROGRAM</b>	
<b>STATIC CONE AND DYNAMIC PENETRATION TEST RESULTS BEFORE PILE INSTALLATION</b>	
<small>FOUNDATION INVESTIGATION AND TEST PROGRAM EXISTING LOCKS AND DAM No. 26 ST LOUIS DISTRICT, CORPS OF ENGINEERS. DACW43-78-C-0005</small>

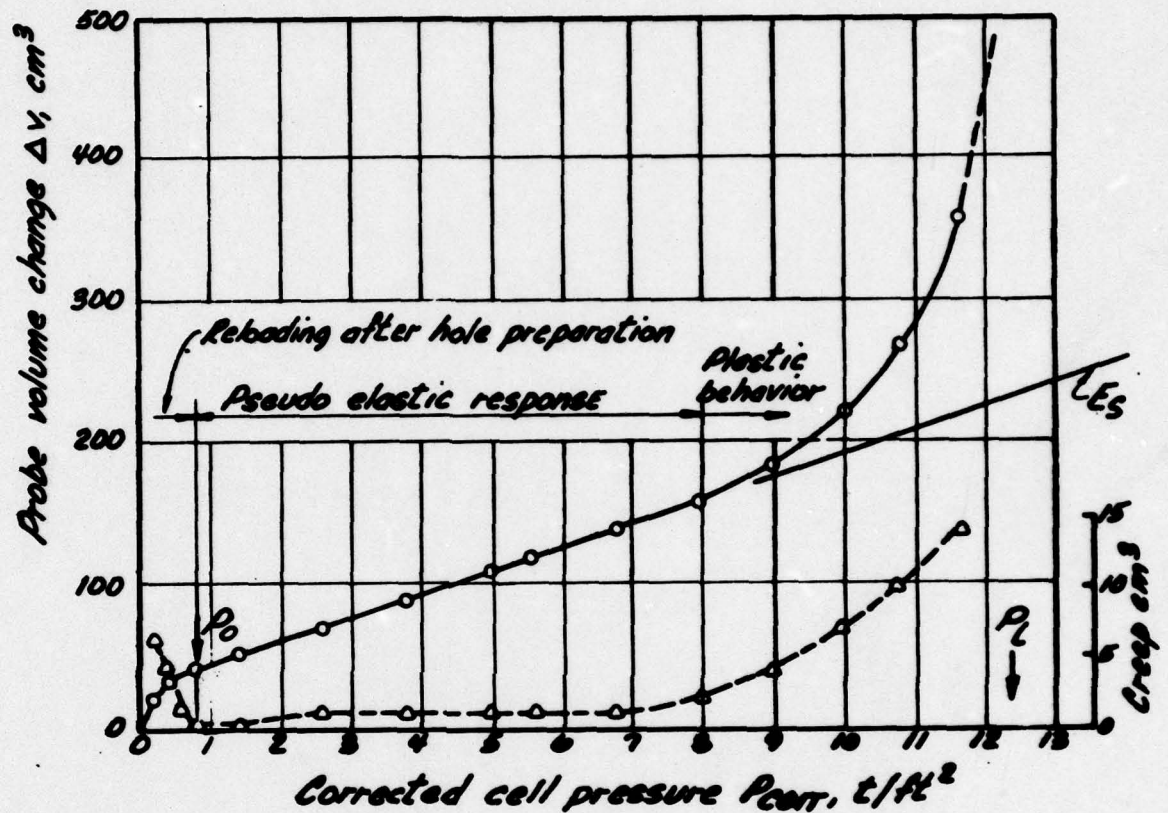
- Probe volume increase vs  $P_{\text{corr}}$
- △-- Creep vs  $P_{\text{corr}}$
- $P_0$  In situ horizontal stress
- $P_2$  Limit pressure
- $E_s$  Deformation modulus

DRILLED-IN PILE TEST PROGRAM	
IDEALIZED PRESSUREMETER TEST RESULTS	
FOUNDATION INVESTIGATION AND TEST PROGRAM	
EXISTING LOCKS AND DAM NO. 24	
ST LOUIS DISTRICT, CORPS OF ENGINEERS.	
DACW49-75-C-0003	
Woodward-Clyde Consultants YTC025 Phase II	Fig. 3.4

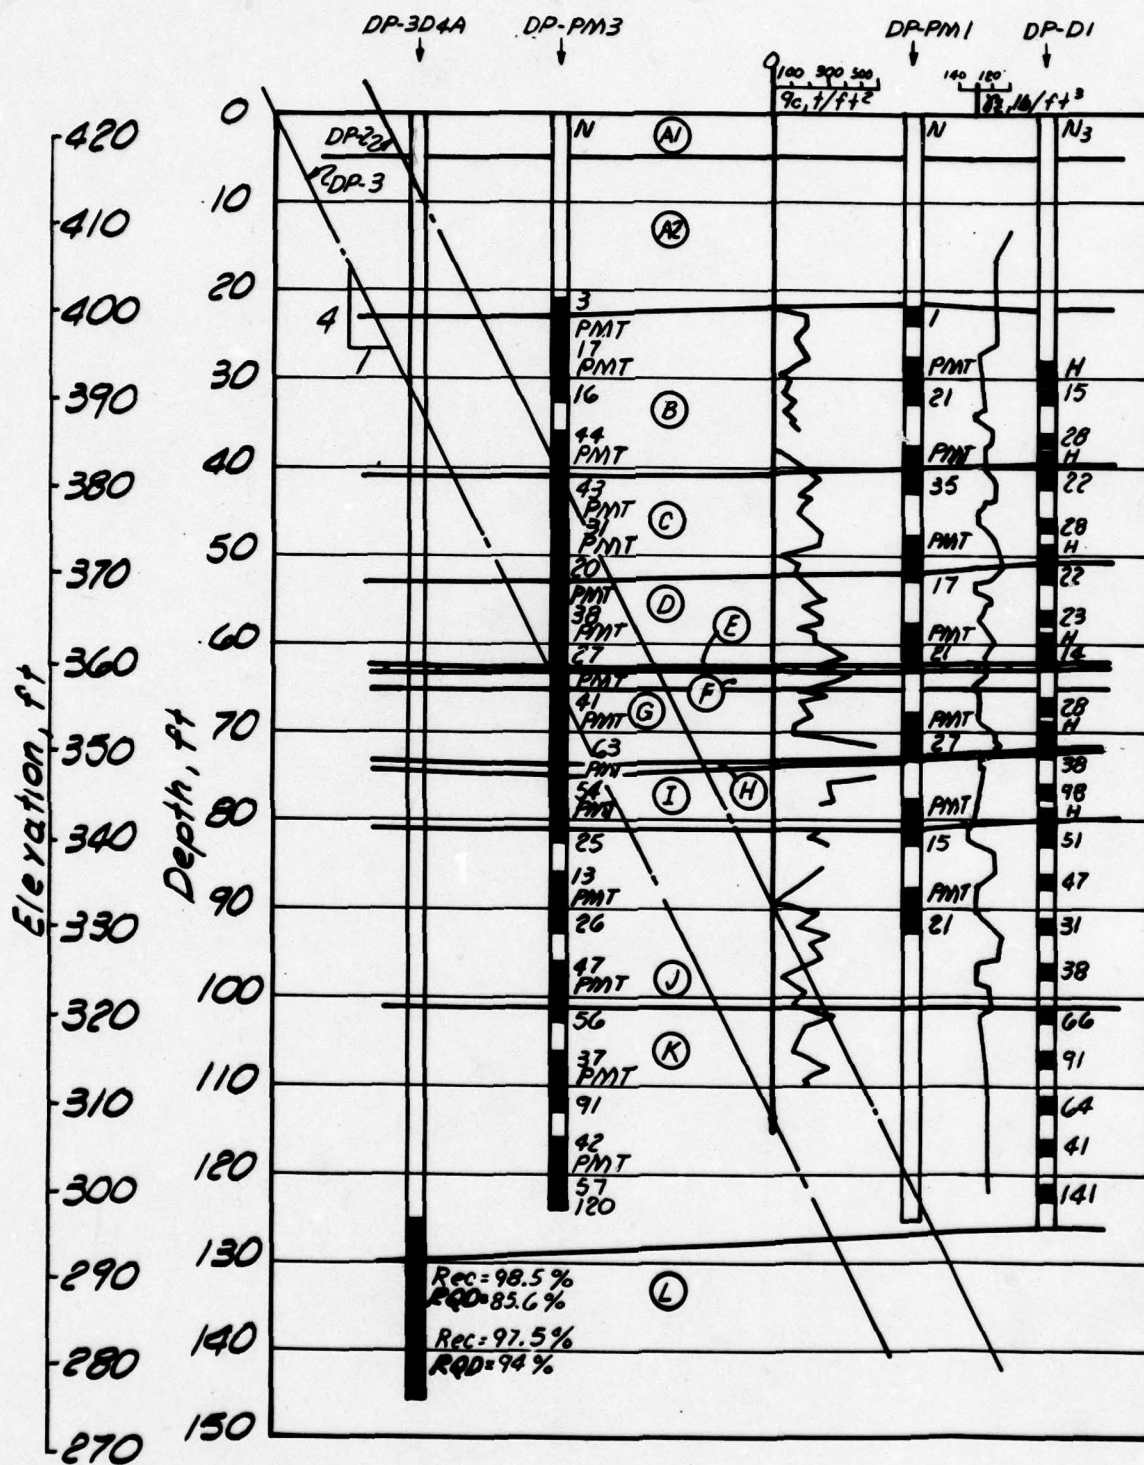
Profile A-A  
Drilled-In Pile Test Area  
Subsurface Stratigraphy

Five minor stratigraphic units were inferred within the recent alluvium (Fig. 3.5). Unit B consists of a loose to medium dense, brown to gray, fine to coarse sand with a trace of silt and a trace of fine gravel (SP). Unit C is more uniform than Unit B, and is predominantly fine to medium sand (SP). Unit D is similar to Unit C, except that it is better graded, coarser-grained, and contains local concentrations of fine gravel. Unit E1 is a thin layer or pocket of firm, gray, silty clay with a trace of fine sand. Unit E1 is typically underlain by a silty fine sand layer, Unit E2. The deepest unit (Unit F) identified in the recent alluvium is a medium dense, gray, fine to coarse sand with thin clay seams and a trace of fine gravel (SP).

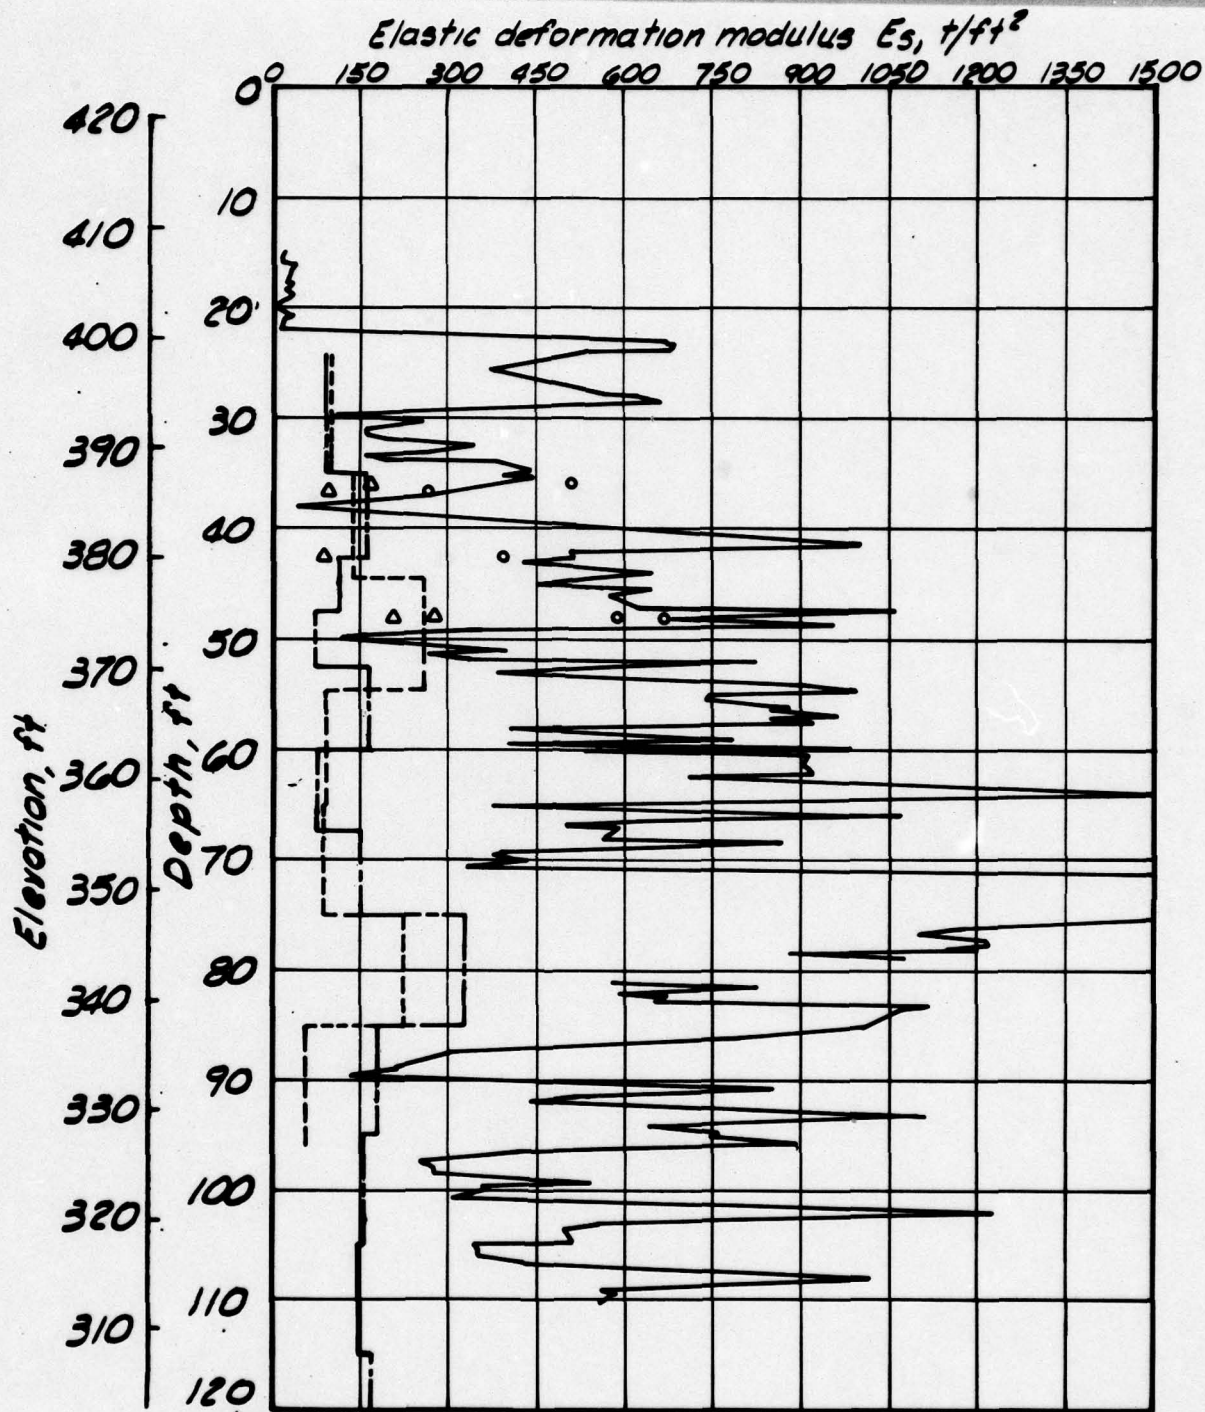
- Static cone penetration tests  
(Yesic 1970)*
- Boring DP-C1
  - Pressuremeter tests
  - Boring DP-PM1
  - Boring DP-PM3
  - CID triaxial tests
  - △ Secant modulus at failure
  - Initial tangent modulus

<b>DRILLED-IN PILE TEST PROGRAM</b>	
<b>ELASTIC DEFORMATION MODULUS PROFILE BEFORE PILE INSTALLATION</b>	
<small>FOUNDATION INVESTIGATION AND TEST PROGRAM EXISTING LOCKS AND DAM No. 26 ST. LOUIS DISTRICT, CORPS OF ENGINEERS. DACW43-78-C-0005</small>	
Woodward-Clyde Consultants	<b>Fig. 3.11</b>

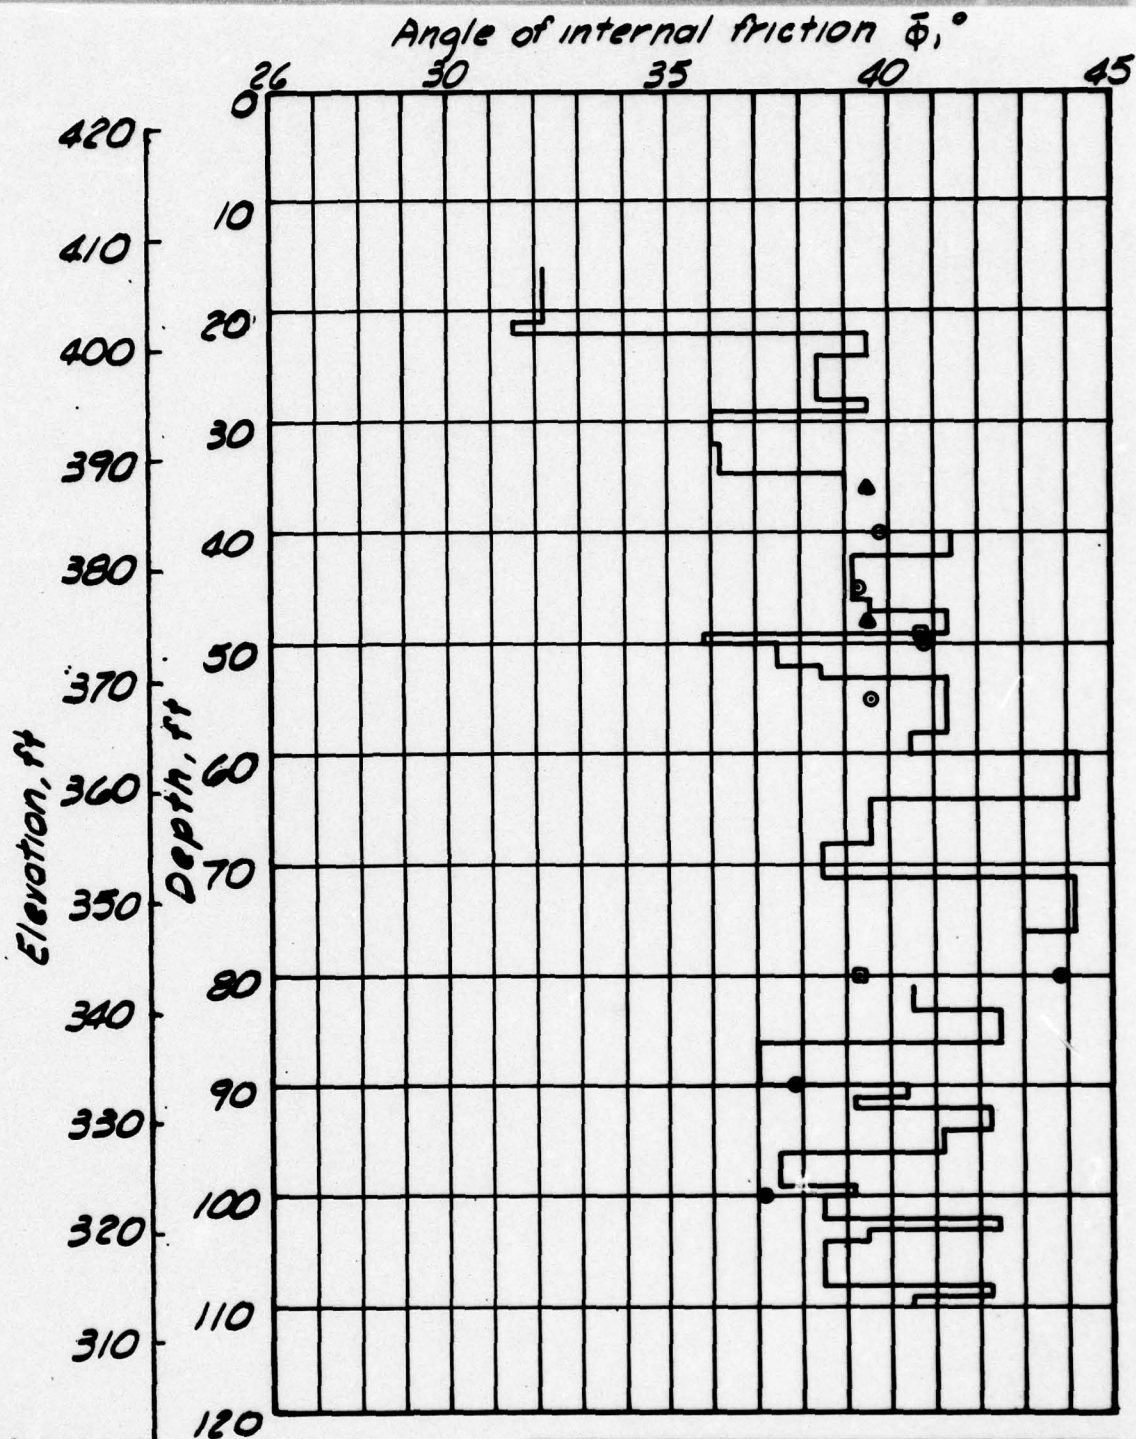
**Legend**  
 Static cone penetration tests  
 (Meyerhoff 1974)  
 — Borings DP-CI  
 Pressuremeter tests (Hughes et al  
 1977)  
 □ Boring DP-PM1  
 ○ Boring DP-PM3  
 ▲ CID triaxial test

<b>DRILLED-IN PILE TEST PROGRAM</b>  <b>ANGLE OF INTERNAL FRICTION PROFILE BEFORE PILE INSTALLATION</b>	
FOUNDATION INVESTIGATION AND TEST PROGRAM EXISTING LOCKS AND DAM No. 26 ST. LOUIS DISTRICT, CORPS OF ENGINEERS. DACW43-78-C-0008	
Woodward-Clyde Consultants YTC825 Phase IX	<b>Fig. 3.12</b>

In the sand, friction angles derived from static cone penetration tests ranged from 36 to 44 degrees with an average value of approximately 40 degrees. Friction angles determined from pressuremeter test results ranged from 37 to 44 degrees and averaged 39.5 degrees. The laboratory triaxial friction angle of 39.5 degrees confirmed the interpretation of the in situ testing results.

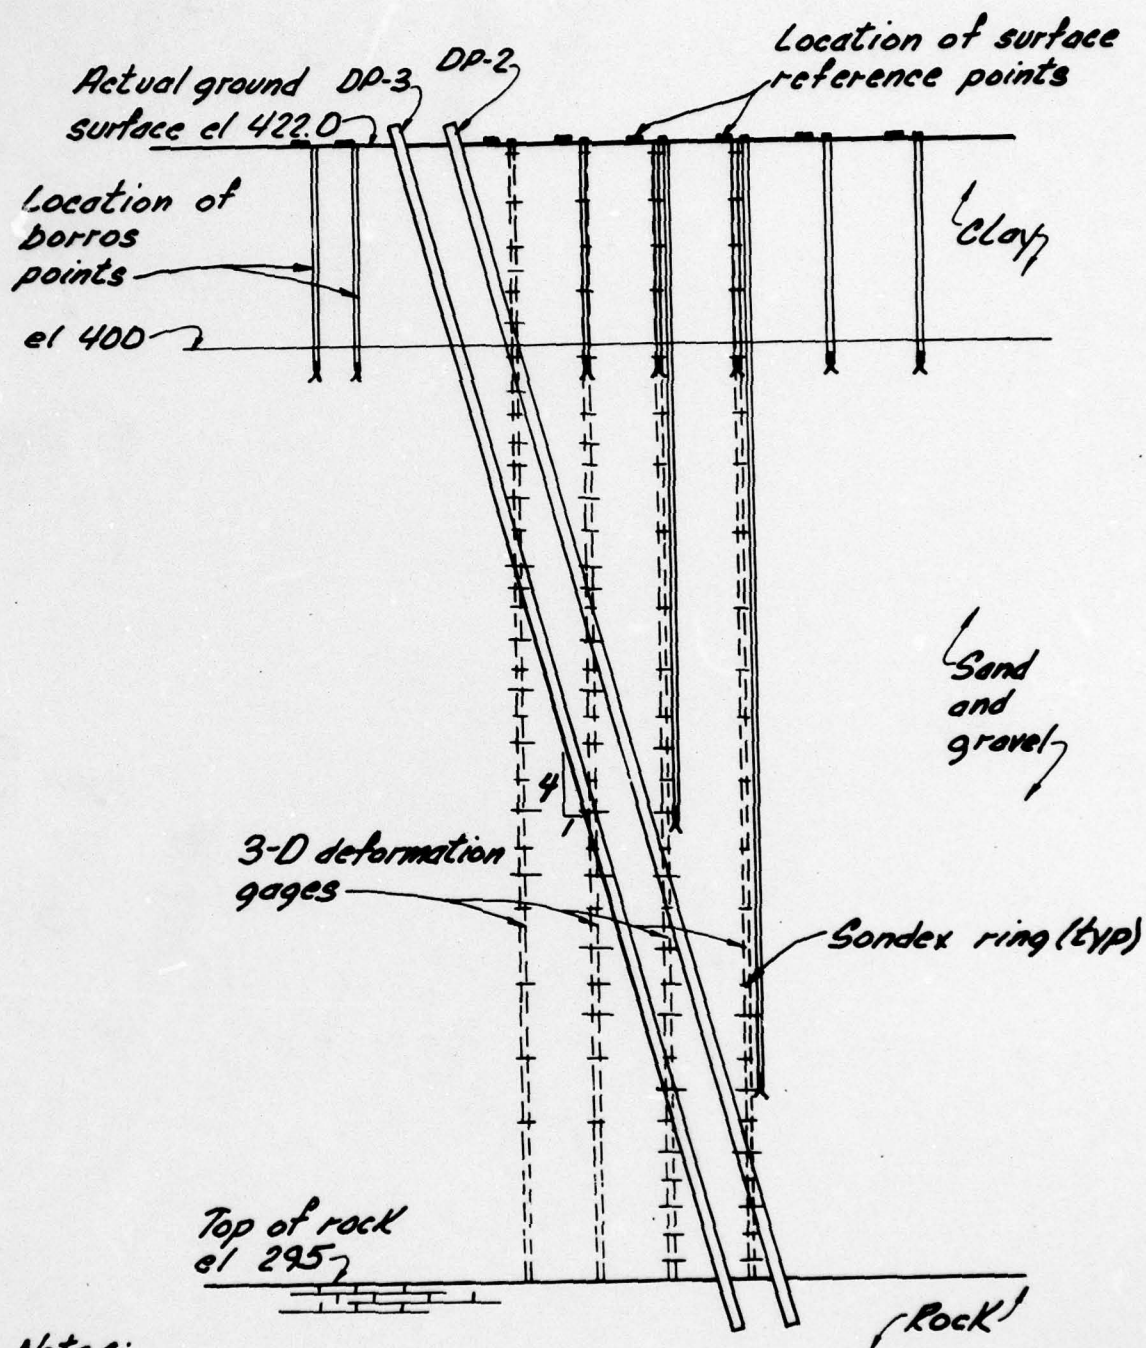
- (1) Surface reference points and borros heave / settlement gages shown are those approximately on centerline of DP2 and DP3
- (2) 3-D deformation gages shown are gages 3D1- 3D4 offset (See plan of instruments, Fig. 4.1)

DRILLED-IN PILE TEST PROGRAM	
PROFILE OF INSTRUMENTATION FOR GROUND LOSS MEASUREMENTS	
FOUNDATION INVESTIGATION AND TEST PROGRAM EXISTING LOCKS AND DAM No. 26 ST. LOUIS DISTRICT, CORPS OF ENGINEERS. DACW43-78-C-0008	
Woodward-Clyde Consultants Y7C825 Phase III	Fig. 4.2

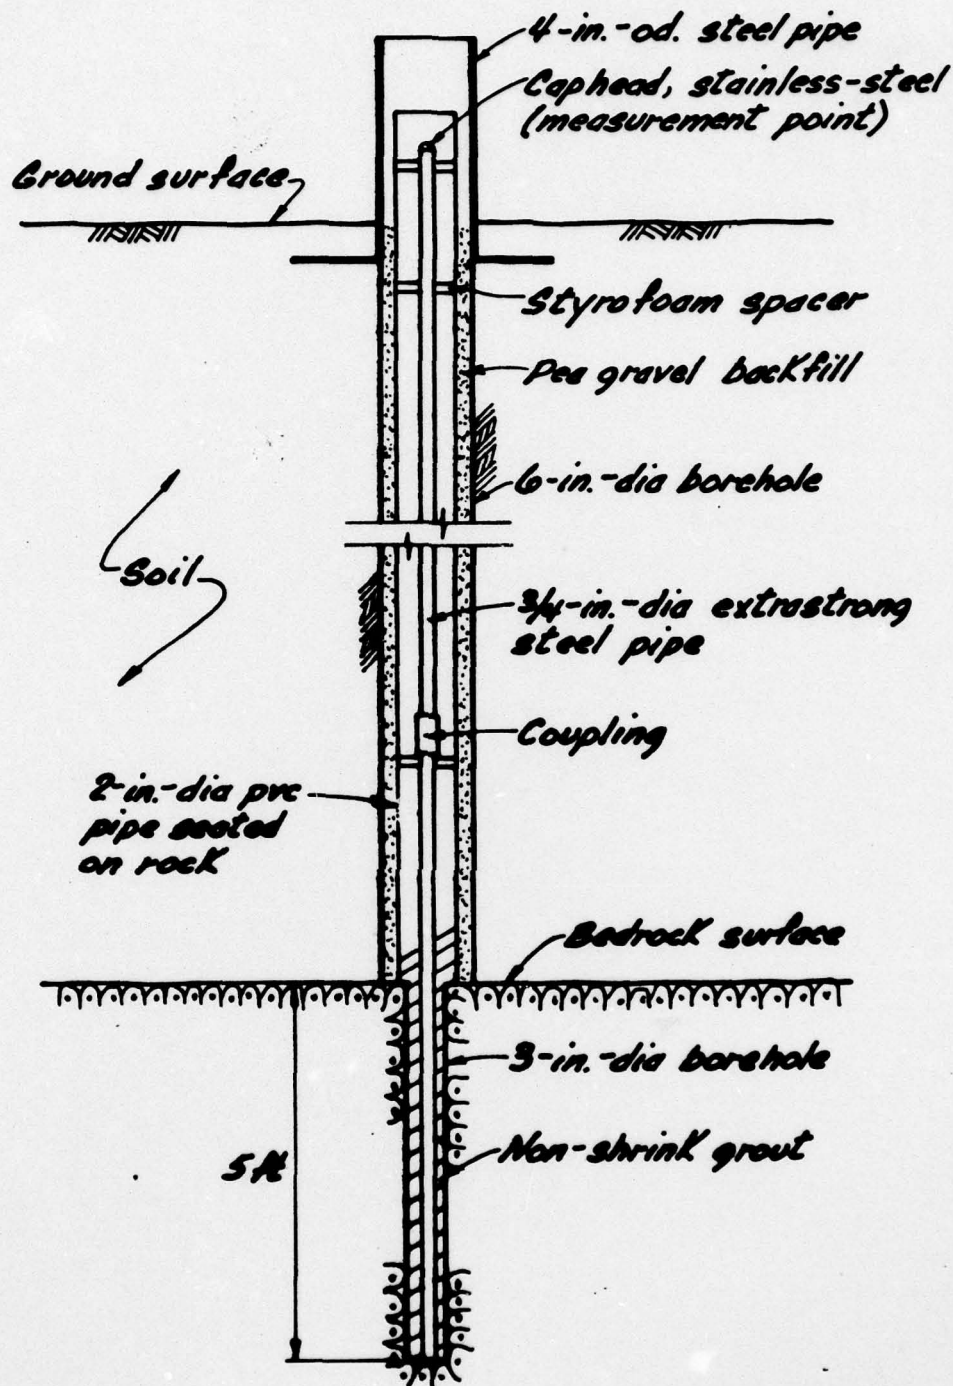
DRILLED-IN PILE TEST PROGRAM	
VERTICAL CONTROL BENCHMARK	
FOUNDATION INVESTIGATION AND TEST PROGRAM	
EXISTING LOCKS AND DAM NO. 26	
ST. LOUIS DISTRICT, CORPS OF ENGINEERS	
RACINE-78-C-0001	
Woodward-Clyde Consultants	Fig. 4.3
V7C825 Phase III
